Transportation Safety Board  
of Canada

**AVIATION**

# REFLEXIONS

Issue 24

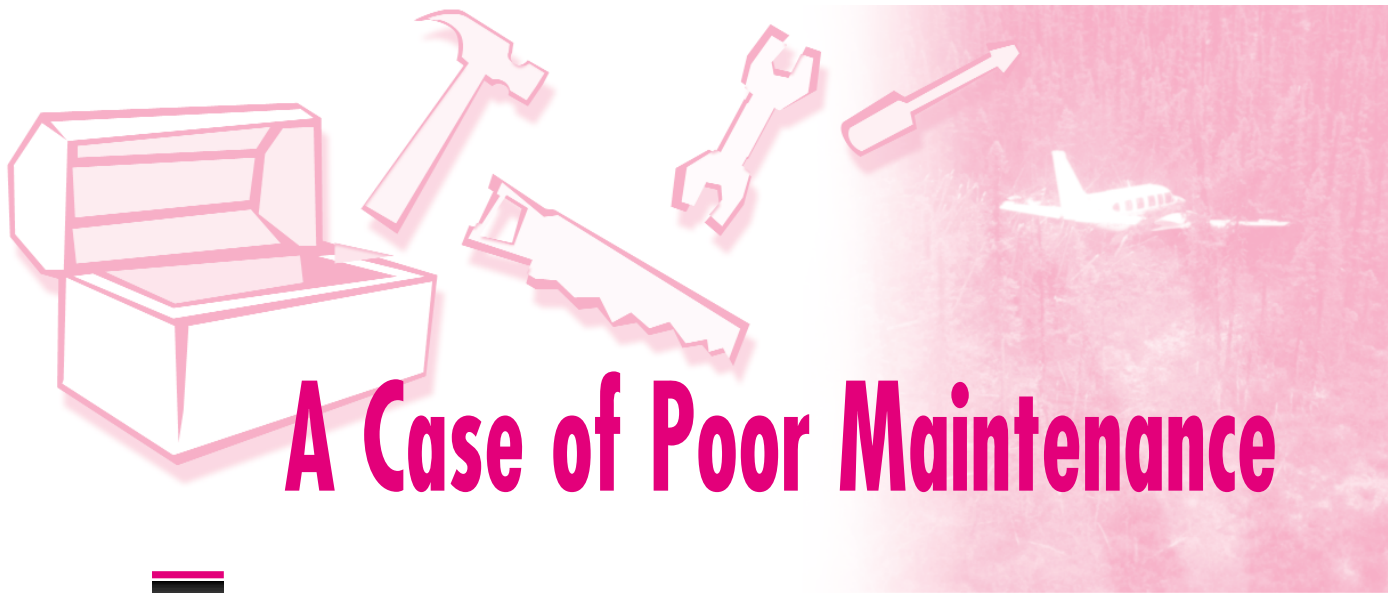
# A Case of Poor Maintenance

**A** modification to the cabin heating unit inconsistent with the manufacturer's recommendations and aviation regulations caused an engine fire in the right engine cowl of the Air Nunavut Ltd. Piper PA-31-350 Navajo during the initial climb. The pilot shut down the engine, but the aircraft could not maintain a positive rate of climb and impacted the ground. The two pilots and two passengers were uninjured in the 20 January 1988 accident at Sanikiluaq, NWT.

*Modifications to the cabin heating unit that were not done "by the book" led to an engine fire on take-off.*

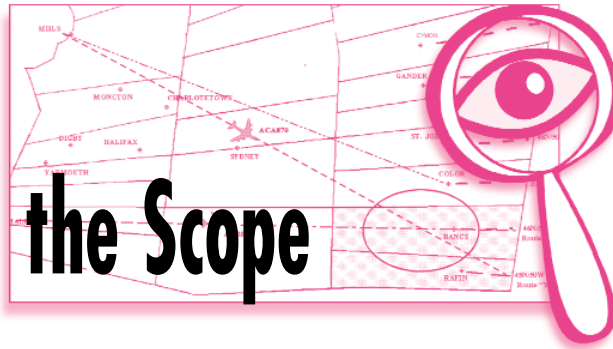
Report No. A98H0002

**A** Boeing 747-400 with 279 persons aboard would have apparently collided with an Airbus A340 with 249 persons aboard over the Atlantic Ocean on 20 July 1998 if the onboard traffic alert and collision-avoidance system (TCAS) had not provided a warning. As it was, the two aircraft closed to approximately 400 feet (121.9 m) vertically and 1.9 miles (3.05 km) horizontally. The required separation in that airspace, about 125 nautical miles (nm) south of St. John's, Nfld., is 1,000 feet (304.8 m) vertically or 5 miles (8 km) horizontally.

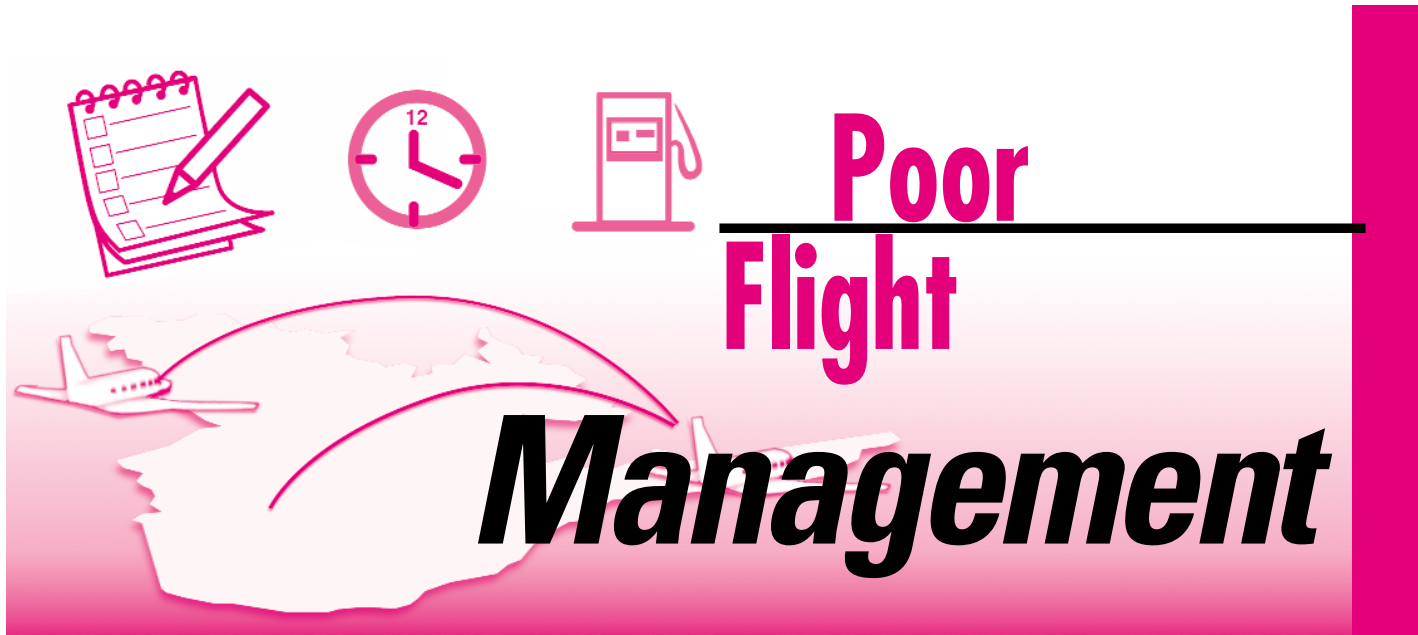
Report No. A98Q0069

**T**he Avionair Inc. Piper PA-31-350 Navajo was unable to land at La Grande Rivière, Que., following the flight from Rouyn because of weather on 14 May 1998. A missed approach was executed, and the aircraft proceeded toward the alternate, La Grande 4. About 15 nautical miles (nm) north of La Grande 3, the engines misfired. The fuel selector lever was reselected, and the engines operated normally for about five minutes, then stopped. The pilot-in-command declared an emergency and proceeded toward La Grande 3 for an approach. The aircraft broke through the cloud layer at approximately 300 feet above ground level (agl), and the pilot set the aircraft down in some trees. One of the passengers suffered minor leg injuries.
